Tree Report

Site Address: Inverell NSW 2360

Prepared For: **Inverell Council**
PO Box 138
Inverell NSW 2360

Report Number: **CD1108**

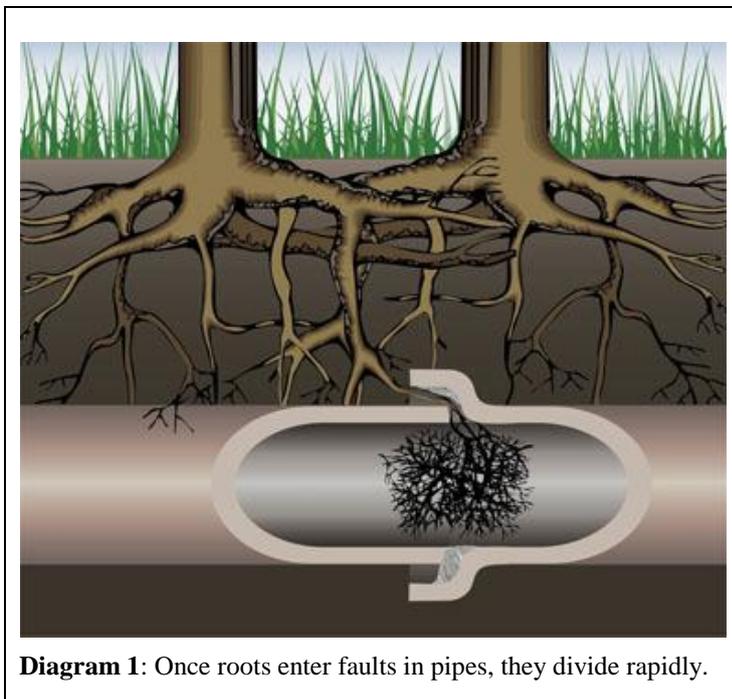
Cracks in pipes often occur over time and the failure of cement joins and rubber seals are quite common. Once a pipe cracks or a joint fails, then pipes start to leak oxygenated and nutrient rich water through those faults into the surrounding soil. If a root comes into contact with this ideal growing environment it then starts to divide rapidly in order to take advantage of the available resources. In this situation it is generally only a question of time before roots come into contact with the fault and enter into the pipe where they divide even more rapidly

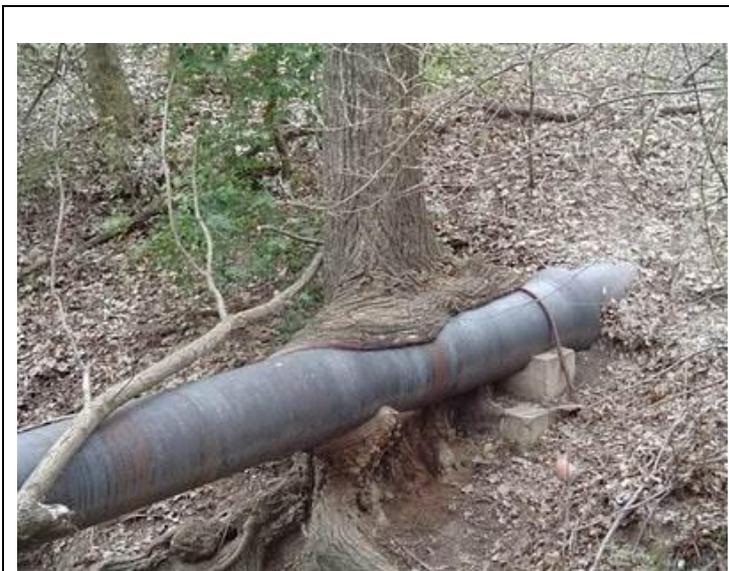
Image 4: There is little to no lateral movement that can be observed in this pipe even though there is no support from soil on the other side of the tree.

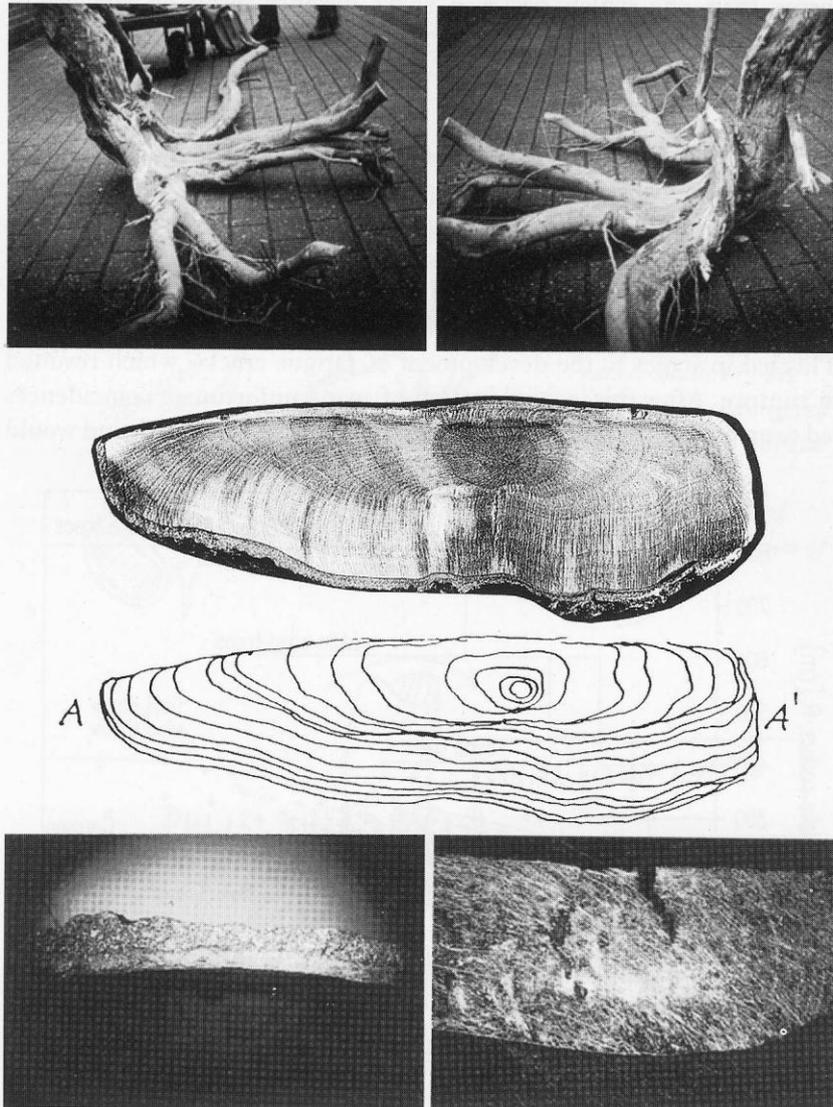
certainly not have occurred for many years if the weld had been properly made or/and not positioned above the root sling. Fig. 60 shows the sling of roots in which the pipe lay, a cross-section sawn through the root – from whose annual rings the load history can be read –, and a section through part of the weld in the pipe. The weld has two clear cracks running in the margin of the weld material, i.e. in the so-called heat-altered zone.

Fig 60. After more than 10 years, the cradling roots were enough to fracture a poorly made welded joint lying above them. The loading history can be read at the saw cut. The poor weld is clearly recognizable.
