VALIDATION REPORT (NCPT PORTION OF SITE)

Liberty Service Station
24-26 Glenn Innes Road, Inverell NSW

North Coast Petroleum and Transport

12 May 2022

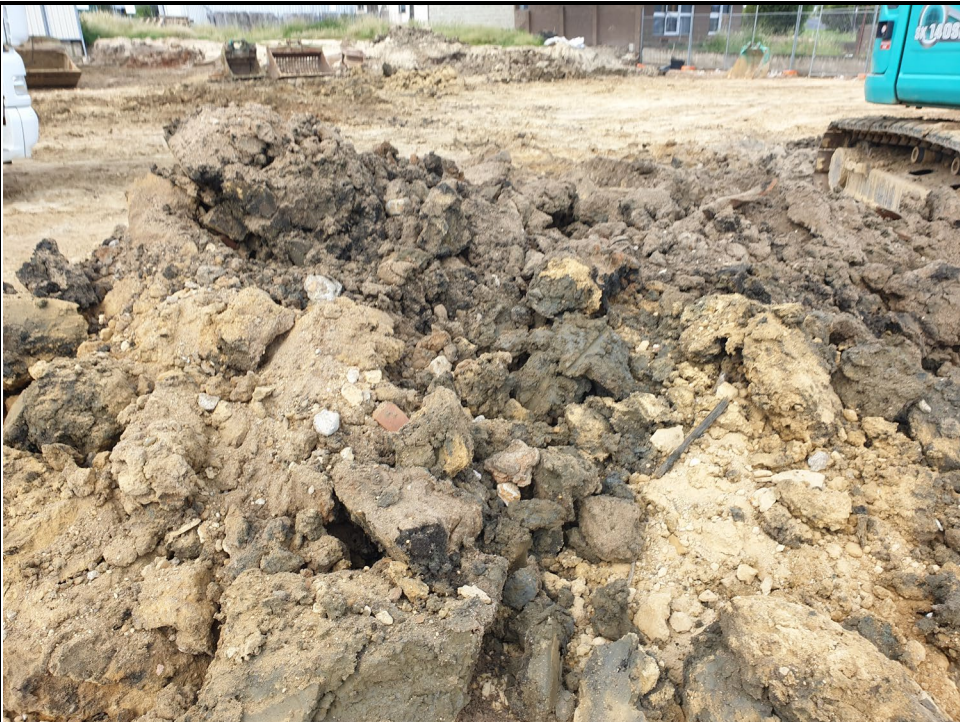
Photo No.	Date	
3	21/03/2022	
Description Image of grease pit waste stockpile. Staining and refuse noted in soils.

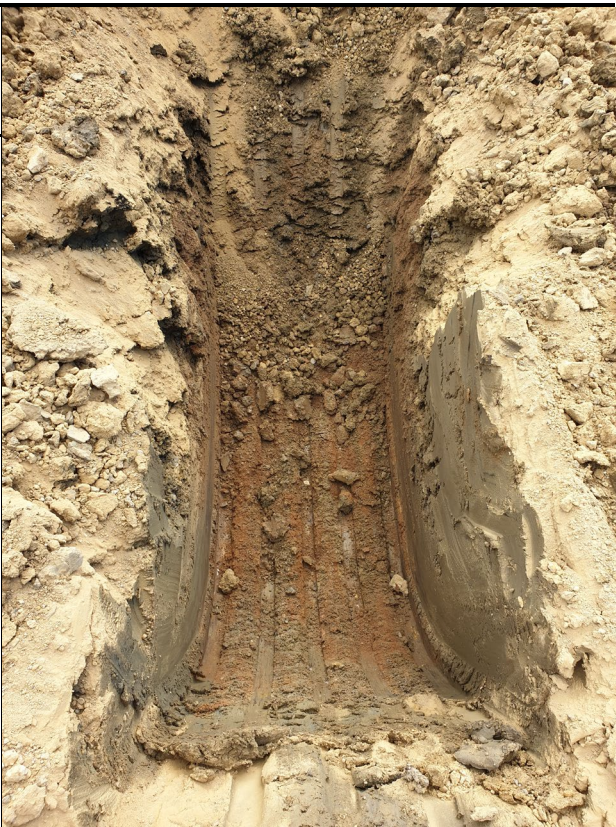
Photo No.	Date	
4	21/03/2022	
Description Image showing hoist 1 location during validation sampling. No hydrocarbon impacts evident.

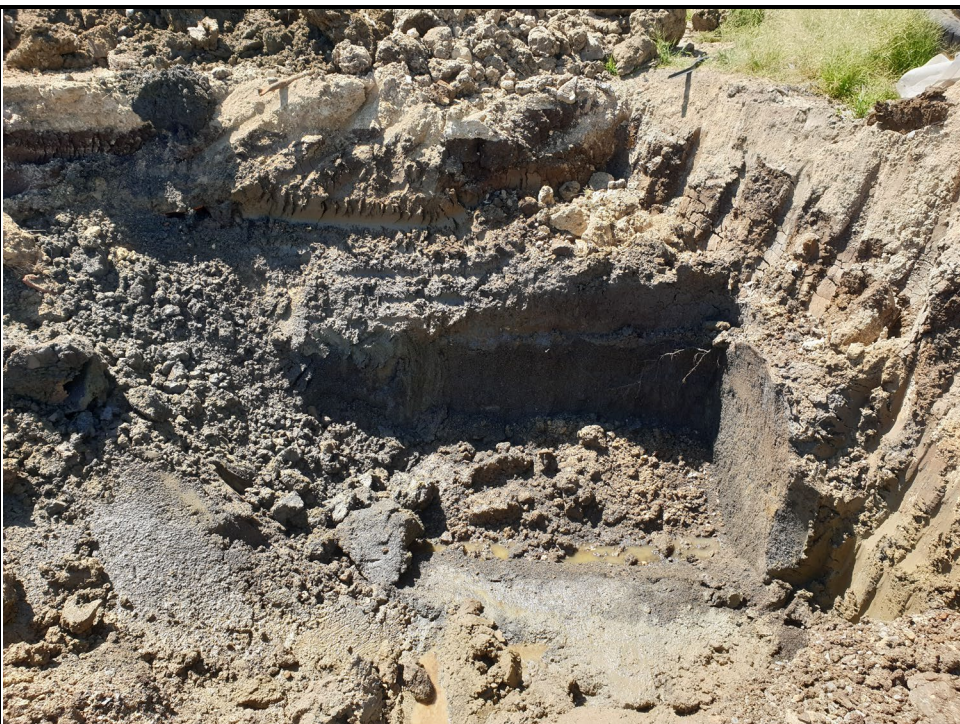
Photo No.	Date	
6	22/03/2022	
Description Image showing the pit after the UST had been removed. Hydrocarbon impacts evident in soils adjacent the UST.

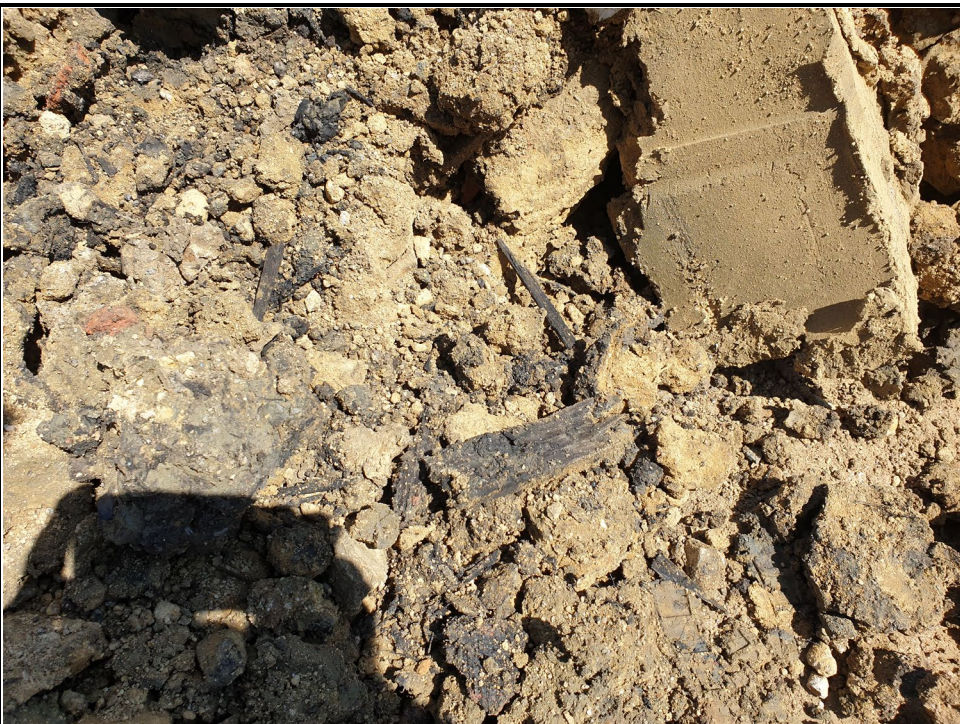
Photo No.	Date	
2	21/03/2022	
Description Image showing hydrocarbon impacted soils

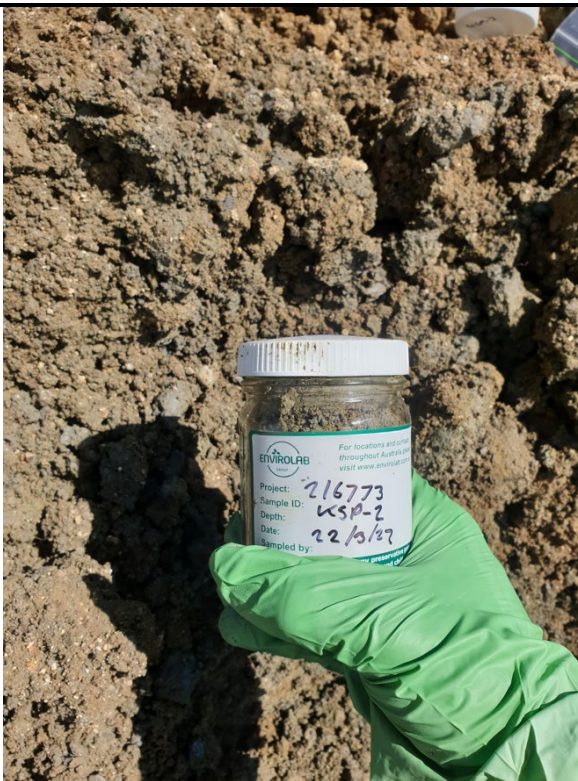
Photo No.	Date	
2	22/03/2022	
Description Sample showing hydrocarbon staining on soil in background.
