Tree Report

Site Address: Inverell NSW 2360

Prepared For: **Inverell Council**
PO Box 138
Inverell NSW 2360

Report Number: **CD1108**

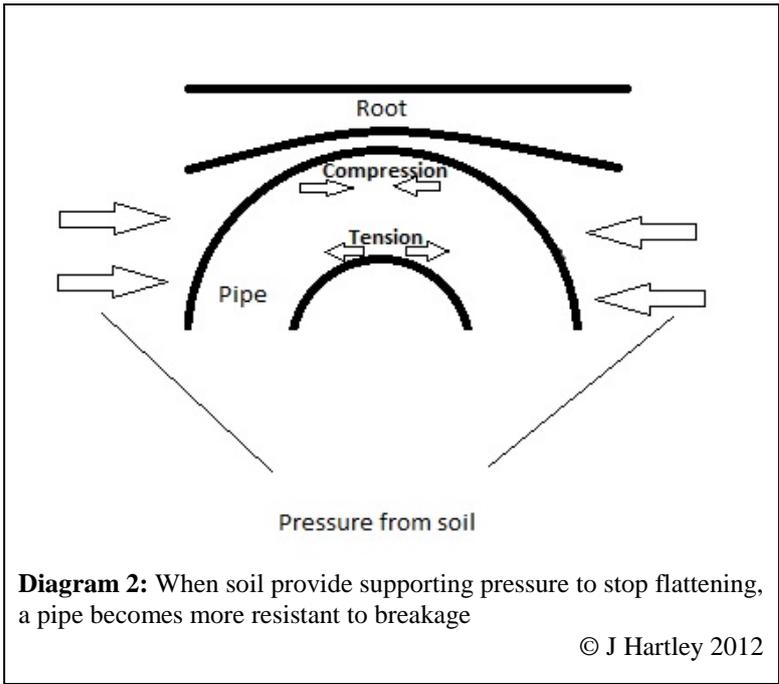
It appears highly unlikely that roots can ever crush or crack pipes simply as a result of their growth in girth unless the pipes is defective or significantly embrittled.

Image 4: There is little to no lateral movement that can be observed in this pipe even though there is no support from soil on the other side of the tree.

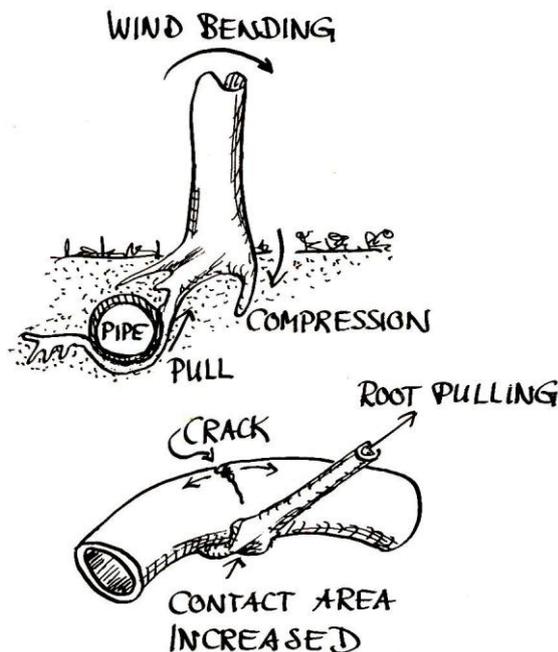
Fig. 55 shows the principle. The length of root, mainly under tension, only yields a little when loaded and transfers the wide movement of the tree jerkily into the pipe. A plane tree root 10 cm in diameter has a mean breaking load of 42,000 kp. The working load is obtained by dividing this by the safety factor for trees $S \sim 4.5$, giving about 9,000 kp. So under moderate wind loading there is roughly the weight of 2–3 elephants pulling sideways on the pipe. Not surprisingly, this can produce cracks on the pipe's upper side.

Fig 55. The tugging-cradling root passing under a pipe on the windward side represents, in the authors' opinion, the worst type of interaction between a tree and an underground service. Cracks appear in the upper side of the pipe.

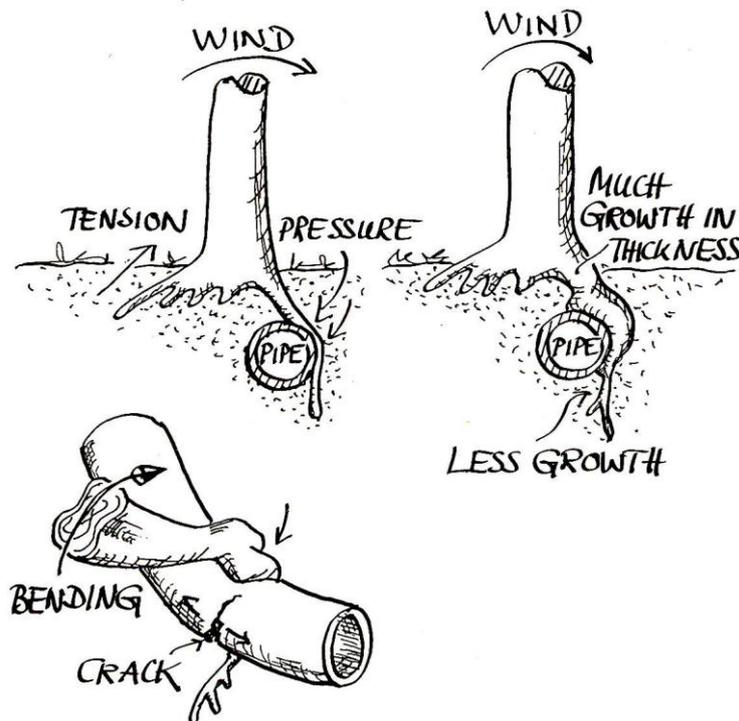
It can be shown theoretically that a root lying on a pipe on the side away from the prevailing wind (lee side) at a distance of 1 m from the tree must be 5 times thicker than the tension sling in Fig. 55 if it is to be much of a danger to the pipe. As Fig. 56 shows, a plate-like root prop forms on the upper side of the pipe, helping to even out the contact stress. The load is not introduced into the pipe here in a jerky fashion but rather as a continuously increasing load with the tree's wind movement, because the partial slackening and jerky tightening of the tensioning sling do not operate here. The tree's movement is damped down more gently and more continuously.

Fig 56. When the pipe is on the lee-side, the risk of its cracking is less than that of a windward-side pipe, unless the roots are considerably thicker than the tugging-cradling root depicted in Fig. 55

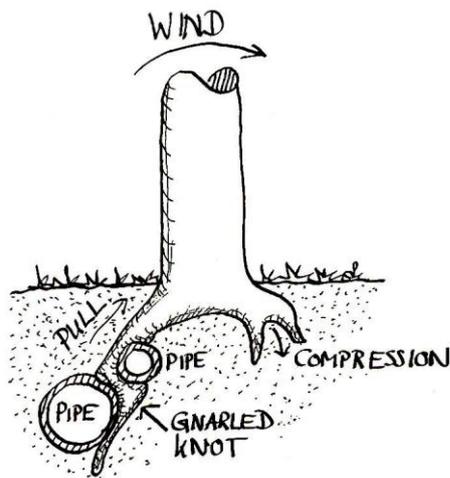
The formation of 'knots' (Fig. 57) is probable, particularly where pipes lie side by side or one above another. These are the consequence of contact stresses in the same way as the piston in Fig. 56. The frictional forces which develop around the pipe resulting from the diversion of the

Fig 57. Knots of roots between pipelines can act like wedges, regardless of the way in which the pipes are placed in relation to the tree, though again the snatching load exerted by roots is the most dangerous effect.

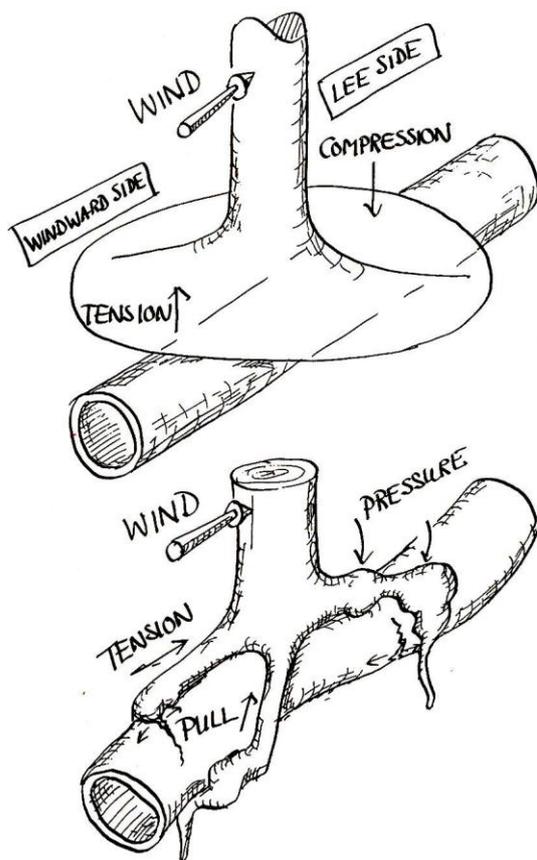
Fig 58. Pipes laid rather shallowly are moderately endangered by trees directly above them if these are subjected to a wind load in the direction of the pipeline.

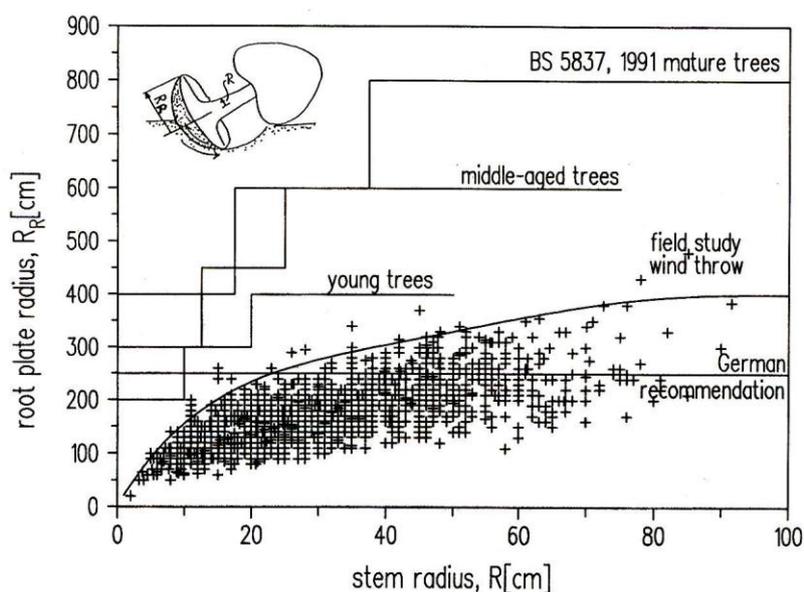
Fig 59. Root-plate radius R_R plotted against stem radius R , as measured above the buttress roots is shown here in relation to root spread values given in BS 5837. The values in BS 5837 include hydrotropic roots that have little or no mechanical role.
